# The Boumerdes, Algeria, Earthquake of May 21, 2003

EERI Learning from Earthquakes  
Reconnaissance Report

October 2003

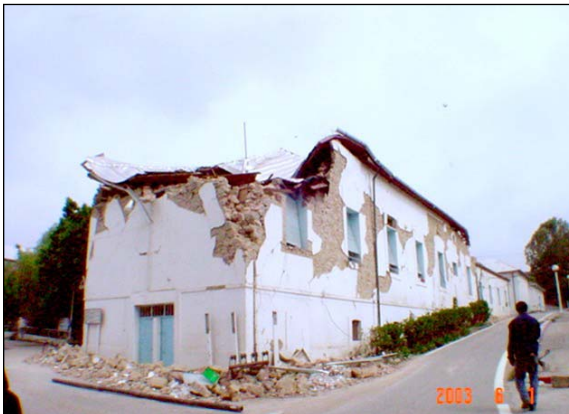
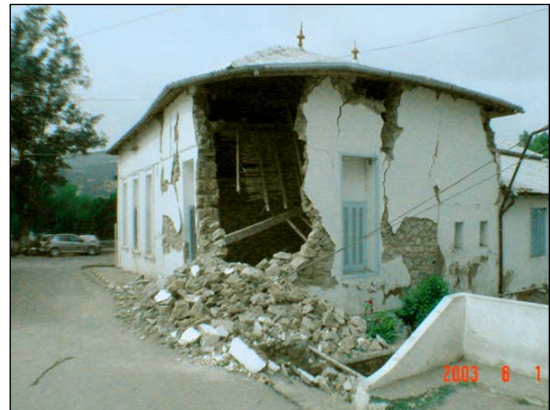
About 50% of the health care facilities in the affected area were destroyed or severely damaged. The hospital in the municipality of Thenia in the epicentral region was destroyed (Figure 4), but the Algerian military established a temporary hospital at the

*Figures 4a and 4b Damage to Thenia Hospital*

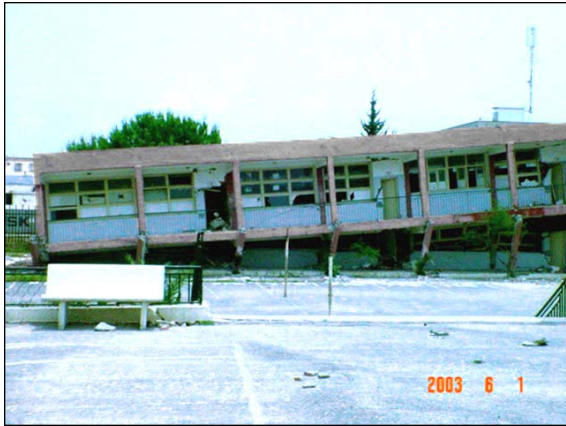
**Figure 6** First floor collapse of school building in Boumerdes.

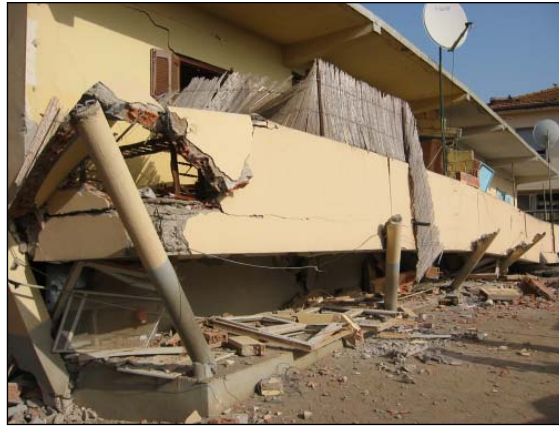
**Figure 7** Elementary school in Corso. Insufficient lateral resisting system.

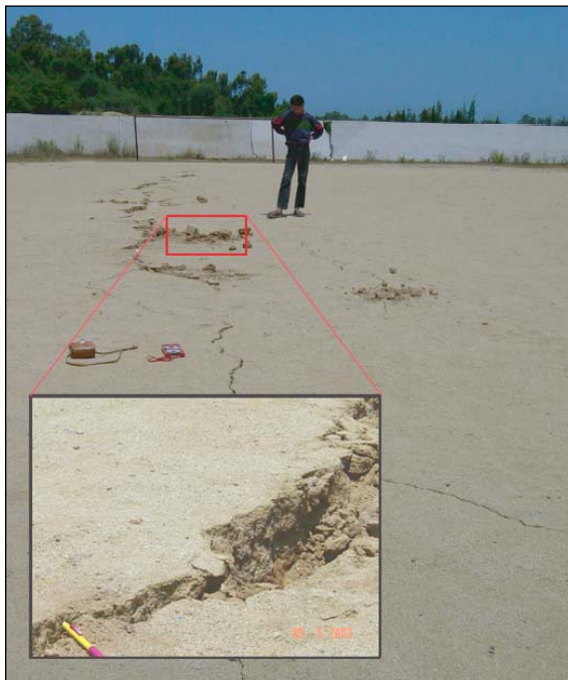
Surface fracturing was observed onshore in the epicentral area; in the area of Corso, in the port region of Zemmouri, and near Dellys. Fractures were observed on the Thyrrenian marine terraces along the coast to the east of Algiers. The fractures were oriented N130° and N20° and were observed in unconsolidated Quaternary sediments discontinuously from Ain Taya to Dellys. These fractures are assumed to be a result of localized surface extension, and not fault rupture. If the hypothesis of the Thenia fault acting as a tear fault to accommodate differential slip is accepted, it is unlikely that slip along the Zemmouri fault can propagate to the southwest beyond the mapped trace of the Thenia fault. See Figure 13.

**Figure 13** Coseismic fractures oriented N20°. These fractures are located at the southwestern end of the main fault, which is situated in the Mediterranean margin. The inset image shows a NNE-SSW thrust fault.

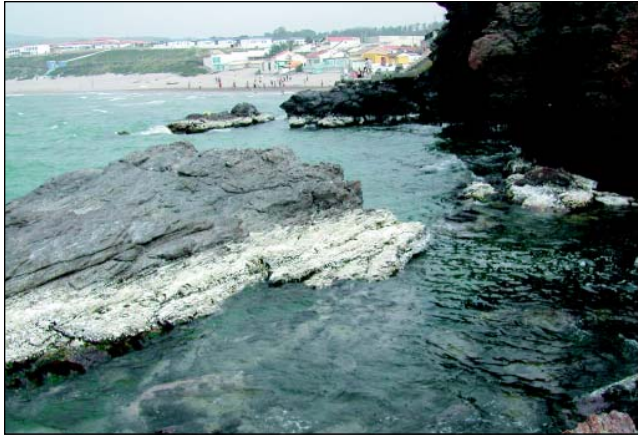
**Figure 14** Seafloor uplift of about 50 cm. The white level represents the thickness of alga that were under the water table before the occurrence of the May 21, 2003, earthquake.

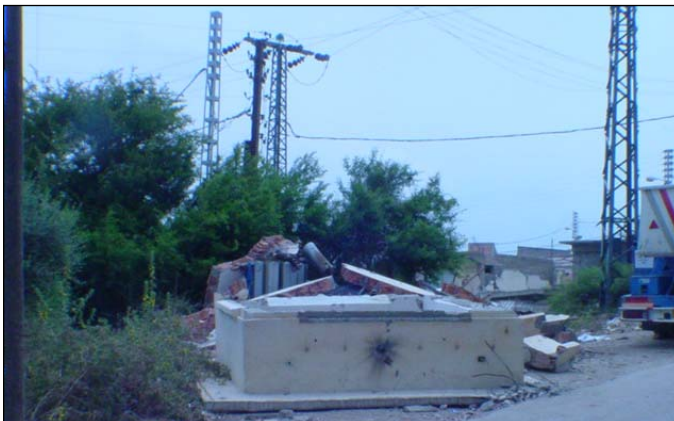
**Figure 17** Concrete cap thrown from its original location.

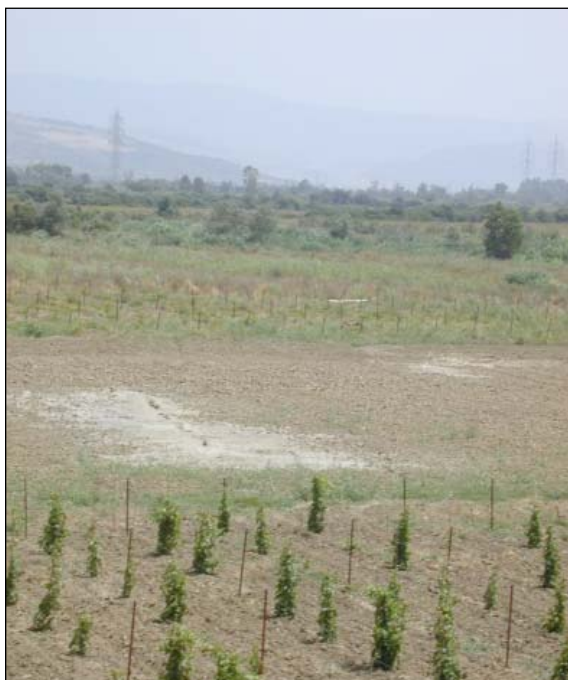
**Figure 21** Liquefaction-induced sand boils near Isser River.

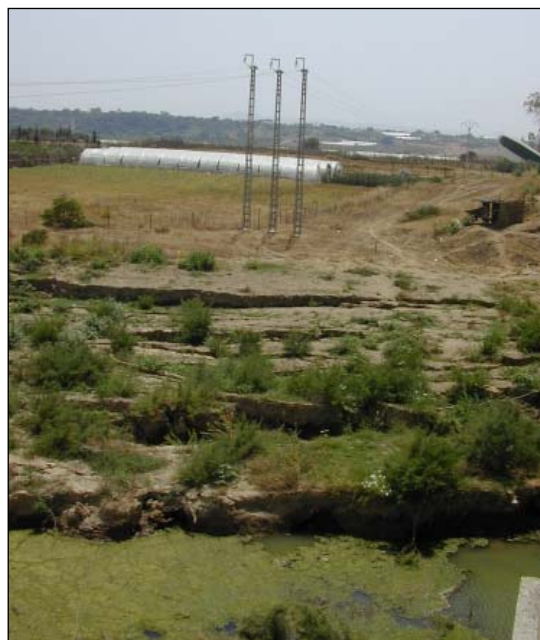
**Figure 22** Liquefaction-induced lateral spreading of the banks of Isser River.

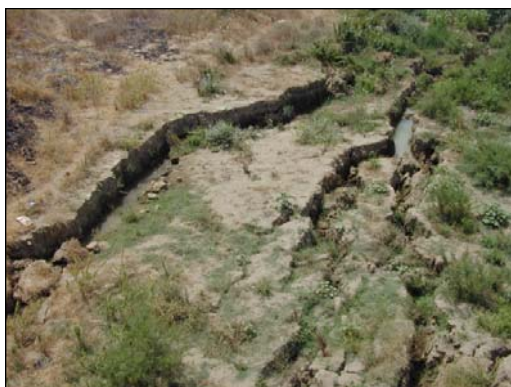
**Figure 23** Close-up view of tension cracks caused by lateral spreading of the river bank.

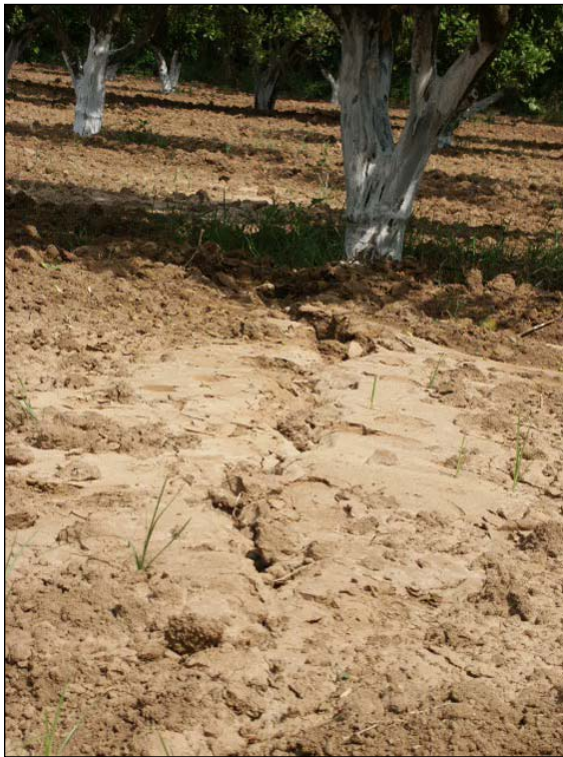
Near the town of Zemmouri, approximately 2 km from the surface projection of the modeled fault rupture area, multiple sites experienced liquefaction (Figures 24 to 26). Based on the distance to the rupture plane and the anticipated near-field (<2 km) peak horizontal ground accelerations (PGAs) from the attenuation relationships, we infer that these sites experienced PGAs in excess of 0.70 g. An excessive amount of sand was ejected during the formation of the sand boils near Zemmouri, where the liquefied sand flowed into and filled an adjacent drainage ditch.

**Figure 24** Liquefaction-induced sand boils in an orange grove in Zemmouri.

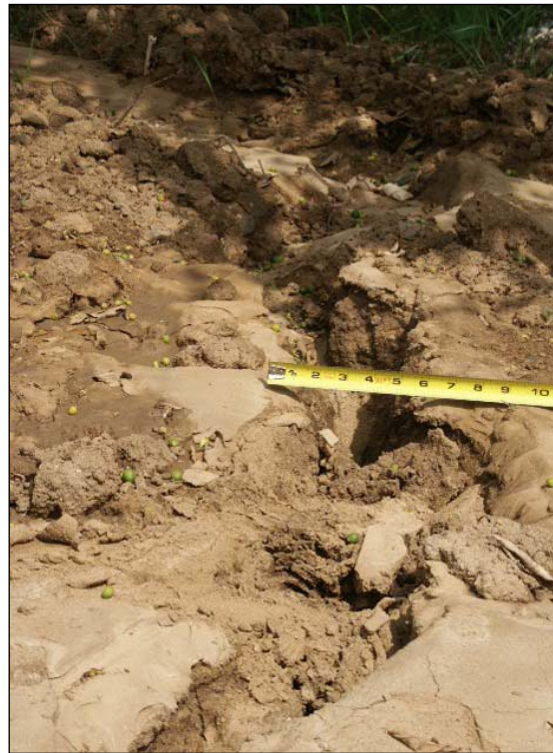
**Figure 25** Close-up of liquefaction-induced sand boils and sand vent in an orange grove in Zemmouri.

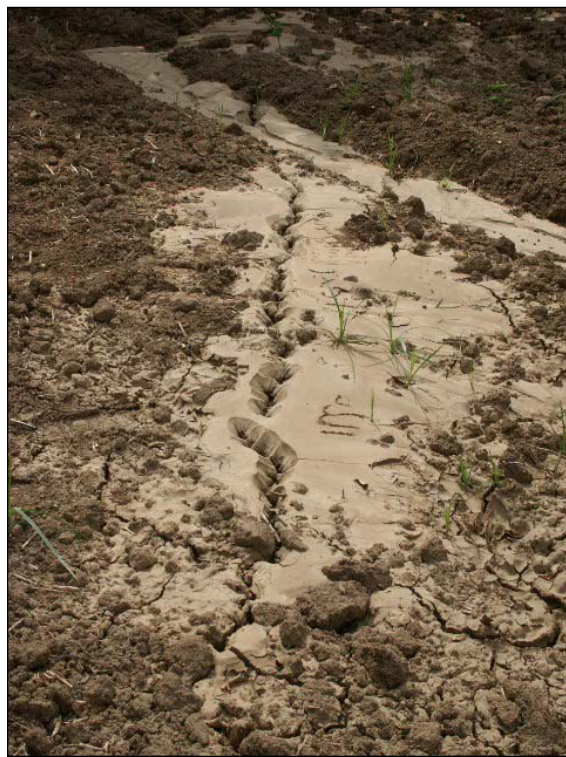
**Figure 26** *Liquefaction-induced sand boils and sand flow into an irrigation ditch in Zemmouri.*

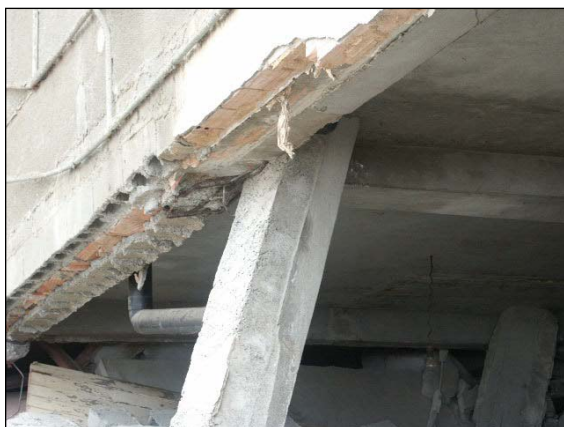
The column shearing occurred at the top of the ground floor columns. A classic case of edge column shearing in a residential building is shown in Figure 27. This resulted in the total disappearance of the first floor (Figure 28), or several floors pancaking (Figure 29). Also refer to Figure A5 in the insert for a satellite image of some of these failures, where building collapse is clearly visible. Most of the first floor column failures were also attributable to extensive openings and insufficient gravity load-carrying elements in the first floor, as is the case with the building shown in Figure 30. It is a typical practice here to use first floors for commercial activities, which essentially makes them soft stories.

**Figure 27** Shearing of column at top of first floor of a residential building.

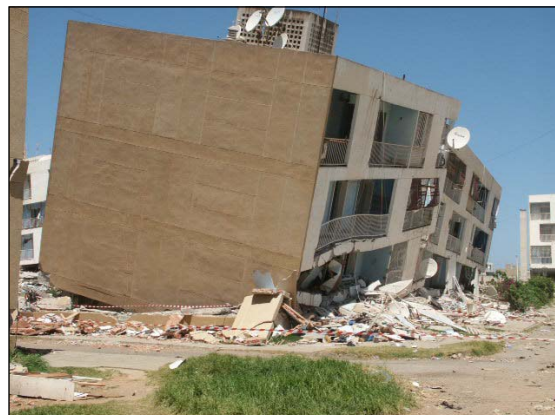
**Figure 28** Total disappearance of the first floor.

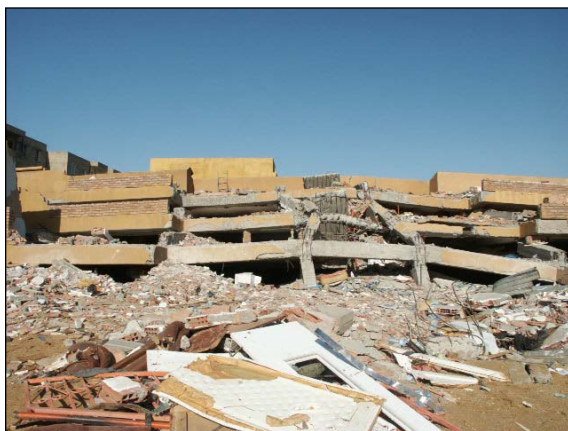
**Figure 29** Several floors pancaked.

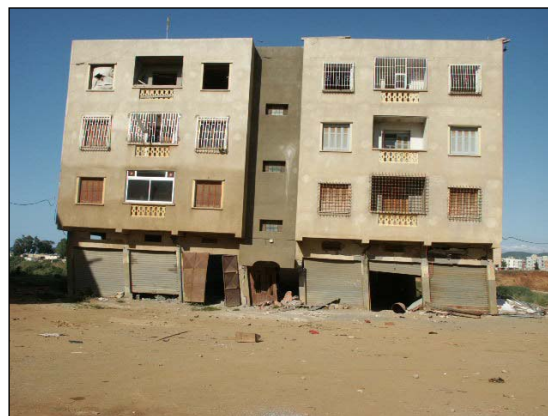
**Figure 30** Soft first floor with minimal masonry supporting walls.

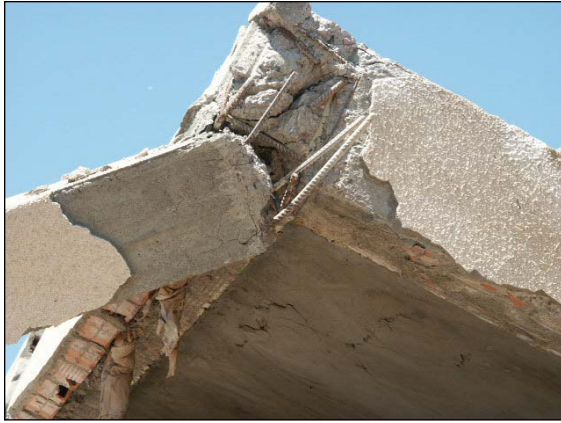
The column shearing is also the result of poor seismic detailing. This is manifested by lack of transverse confinement (Figure 31) and improper longitudinal reinforcement joint connection. The failure is a combination of reinforcement buckling and concrete crushing. Lack of ductility and insufficient reinforcement in beams resulted in brittle failure, as shown in Figure 32. The extremely poor quality of concrete was another factor in the failures.

**Figure 31** Shearing of corner column due to lack of transverse confinement and poor seismic detailing.

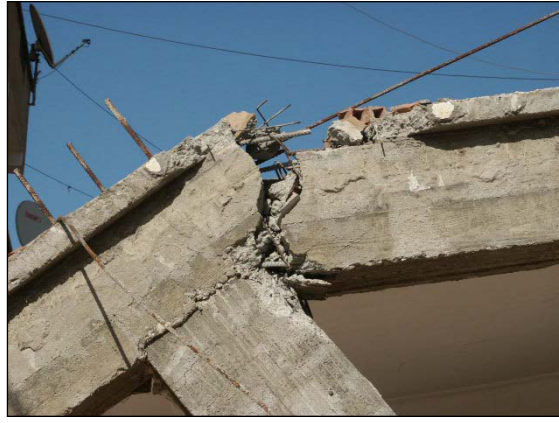
**Figure 32** Failure of beam at beam-column due to lack of development of reinforcement and insufficient ductility.

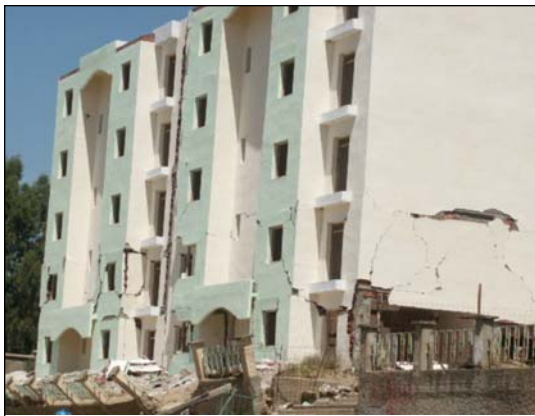
**Figure 33** Failure of masonry infill walls.

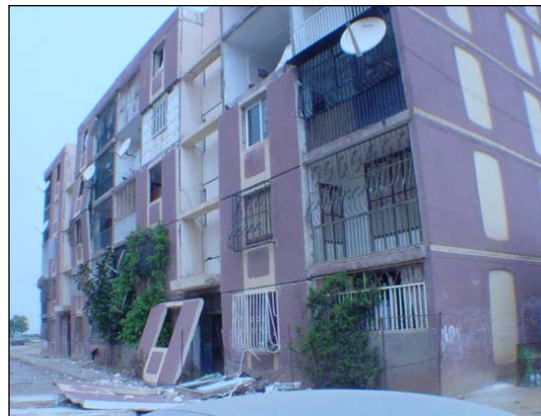
**Figure 34** Failure of precast façade elements in cast-in-place concrete tunnel buildings.

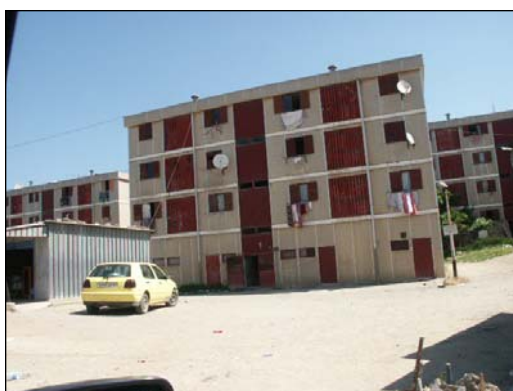
**Figure 35** No failure of steel-frame structure with lightweight infill panels.

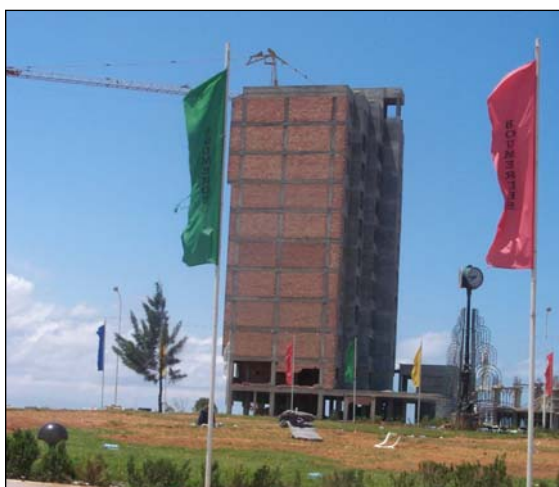
**Figure 37** 11-story RC frame building in Boumerdes — no damage in resistant structure.

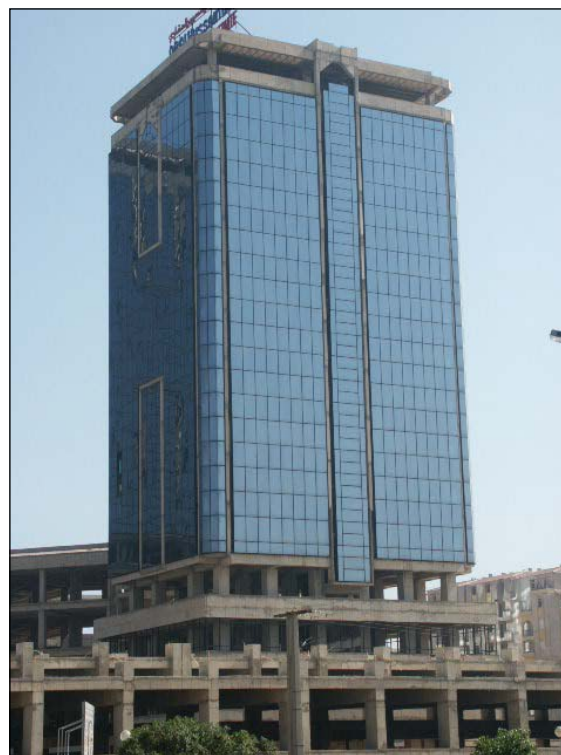
**Figure 36** No failure of the glazing system of an R/C high-rise building.

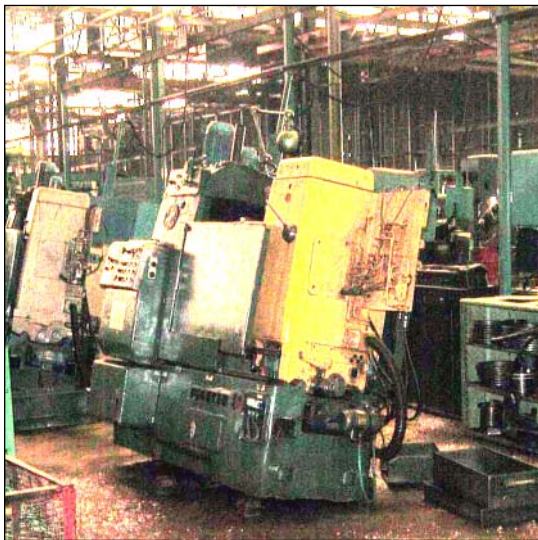
**Figure 39** Poorly anchored machine tool.

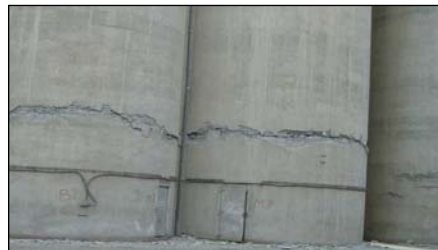
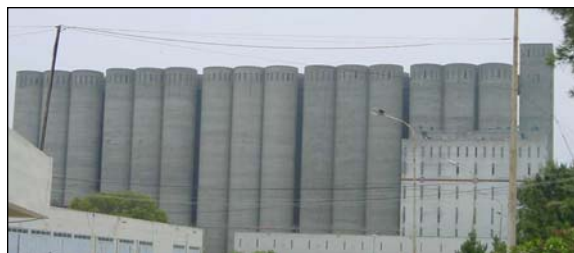
**Figures 40 and 41** Severely damaged grain storage silo in Corso.

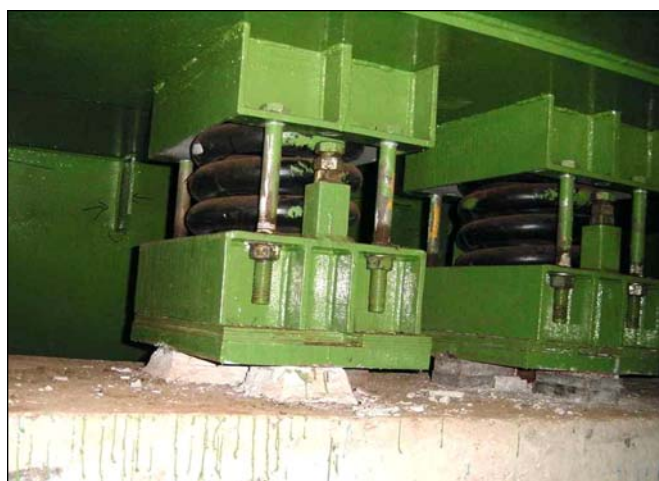
**Figure 42** Good performance of vibration isolators.

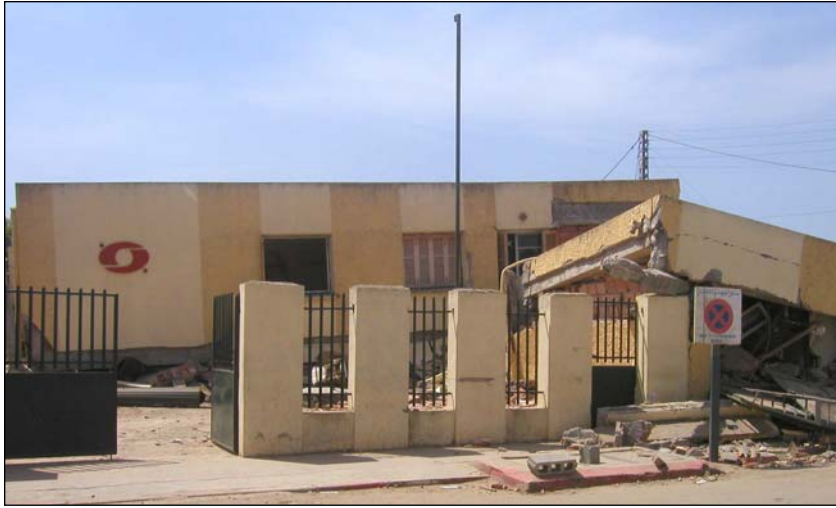
**Figure 44** Collapsed telecommunications center in Zemmouri.

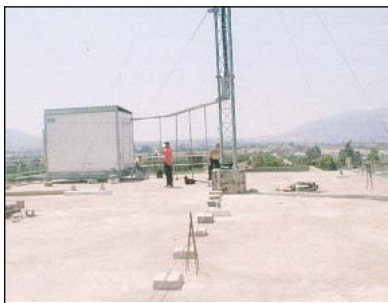
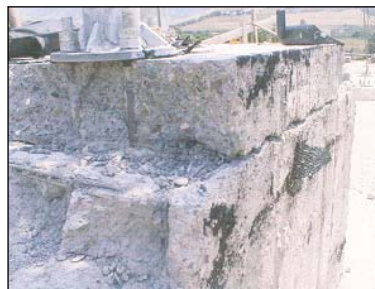
**Figures 45a and b**  
Typical anchorage failure of antenna.

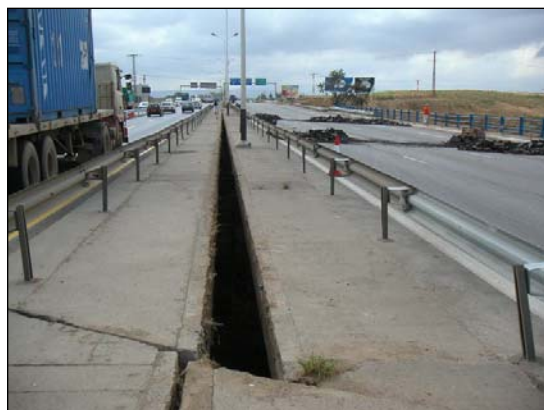
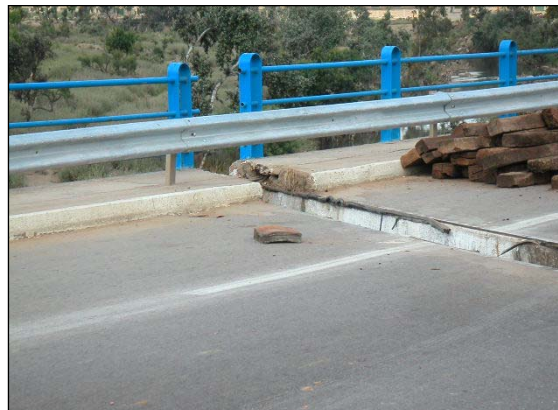
*Figures 46 a and b Damage to Highway 5 Bridge.*

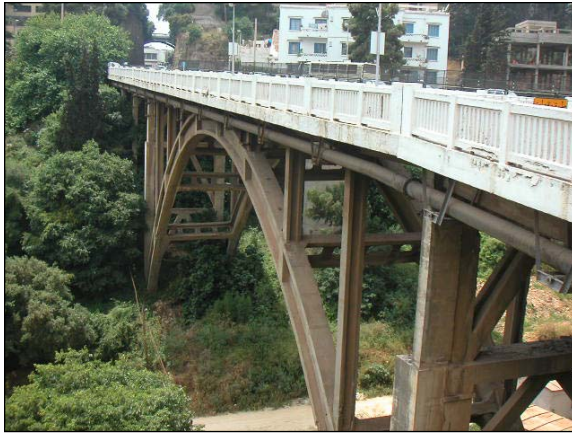
The Hydra Bridge, an arch bridge more than 100 years old, located in the southwest part of Algiers about 60 km west of the epicenter, sustained damage to the rib-arch connections and was closed to traffic (Figure 47). However, its closure did not affect traffic significantly because a duplicate bridge had been recently built next to it. More details of typical bridge failures in the epicentral area are shown in Figure 48.

**Figures 47a and b**  
Damage to the old arched bridge of Hydra.

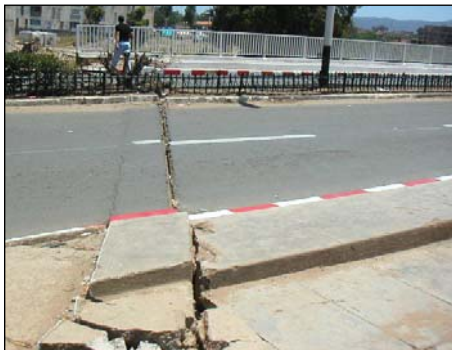
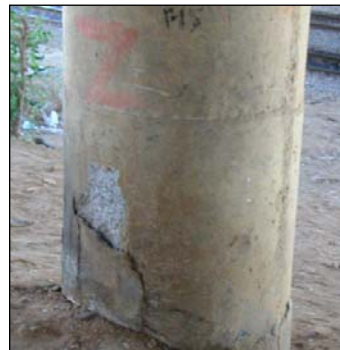
**Figures 48a and b**  
Typical minor, localized  
damage to bridge  
structures.

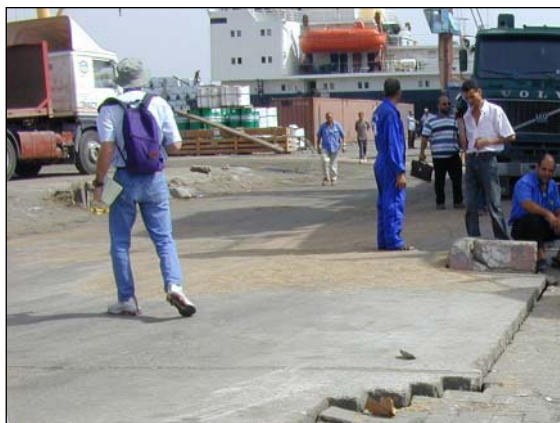
**Figure 49** Differential settlement between the quay walls and backland, Port of Algiers (vertical offset toward the water).

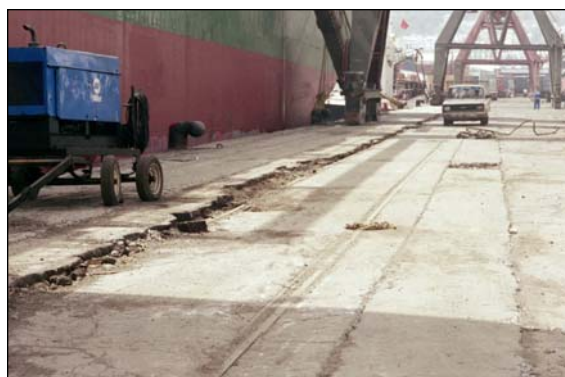
**Figure 50** Differential settlement between quay wall and backland, Port of Algiers (vertical offset away from the water).

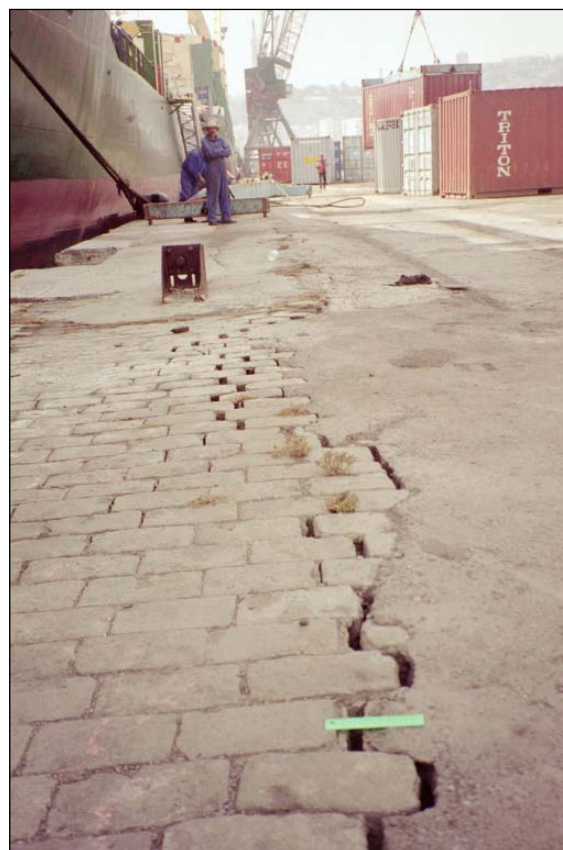
**Figure 51** Tension cracks longitudinal to the quay wall indicating lateral wall movement at the Port of Algiers.

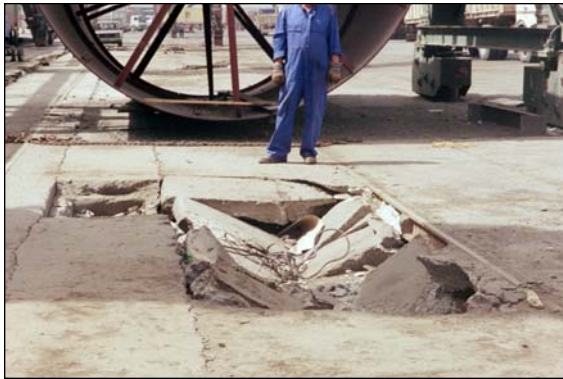
**Figure 52** Loss of ground support under concrete pavement at the Port of Algiers.

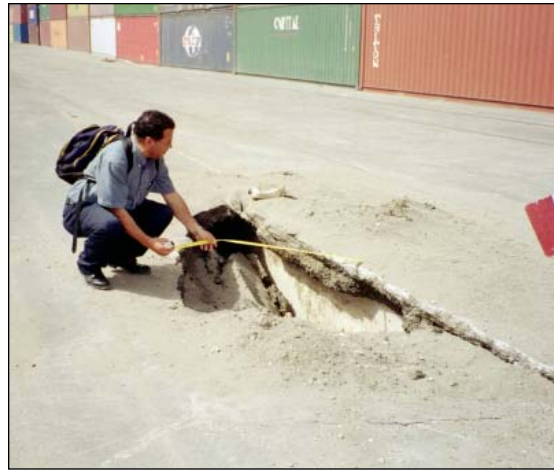
**Figure 53** Cavity caused by loss of soil support due to liquefaction at the Port of Algiers.

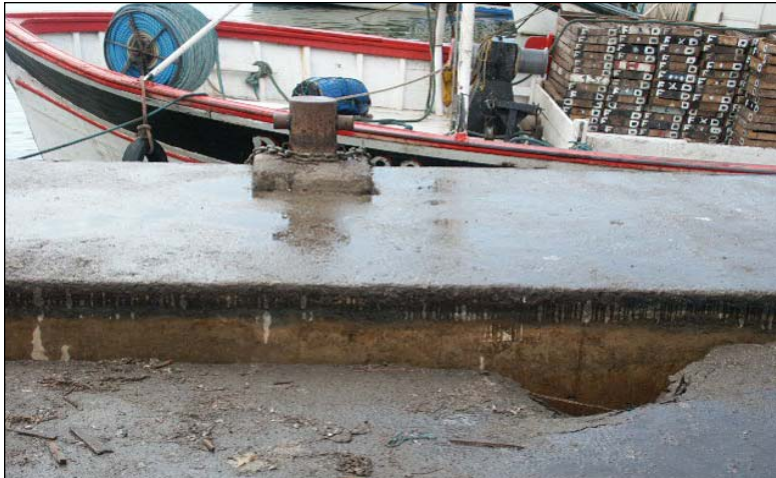
**Figure 54**  
Settlement (>0.3 m)  
behind pier in the harbor of  
Zemmouri El-Bahri (close to  
the epicenter).

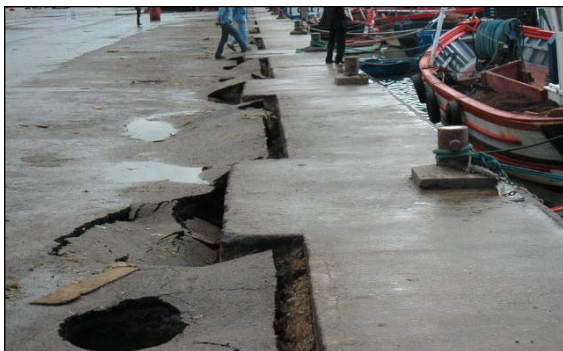
**Figures 55a and b**  
Additional views of  
settlement behind pier in  
the Harbor of Zemmouri-  
El-Bahri

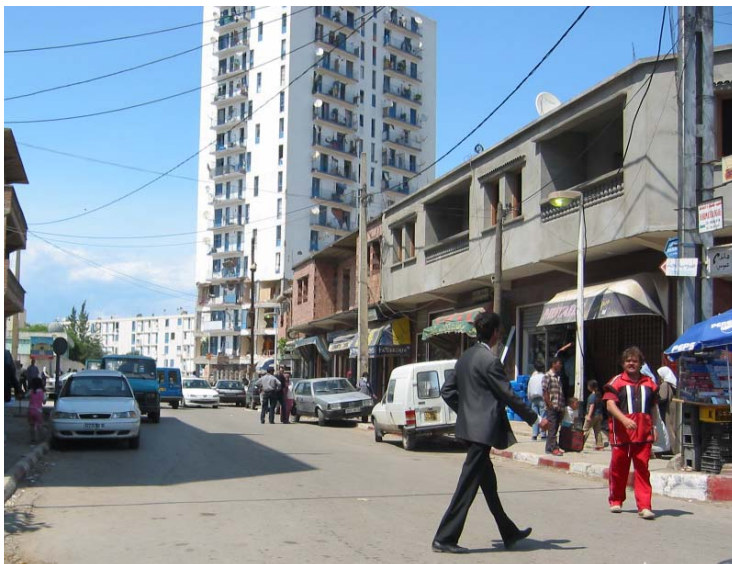
*Figure 57 Apartment tower in Reghaia heavily damaged in the main shock. This photo shows an evacuated tower three hours before its total collapse during the first strong aftershock (M5.8).*
