# The Boumerdes, Algeria, Earthquake of May 21, 2003

EERI Learning from Earthquakes  
Reconnaissance Report

October 2003

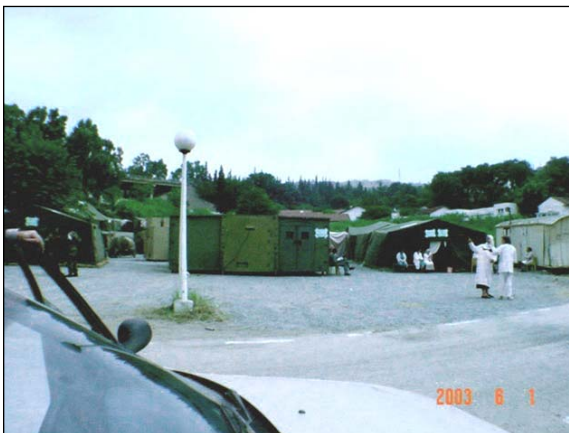
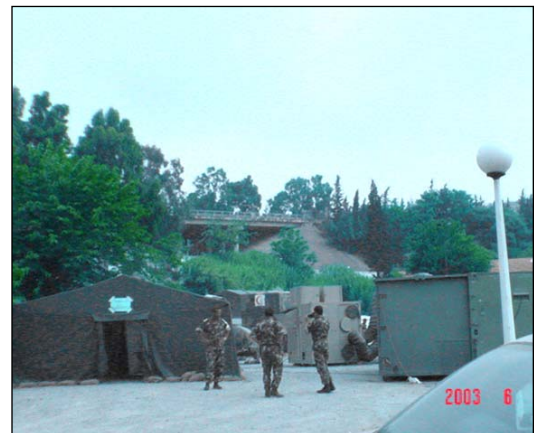
About 50% of the health care facilities in the affected area were destroyed or severely damaged. The hospital in the municipality of Thenia in the epicentral region was destroyed (Figure 4), but the Algerian military established a temporary hospital at the

*Figures 5a and 5b Temporary hospital to replace lost Thenia Hospital*

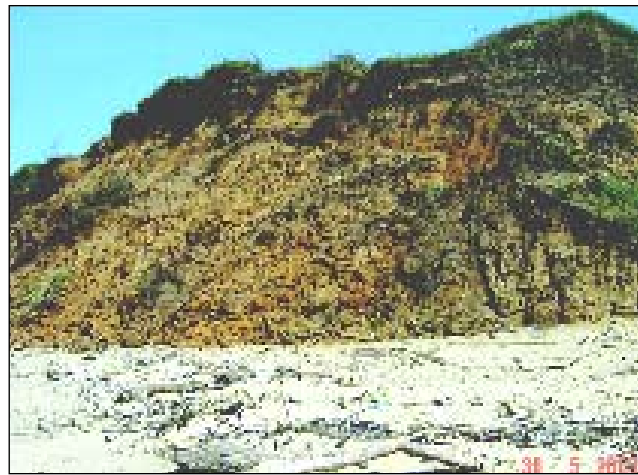
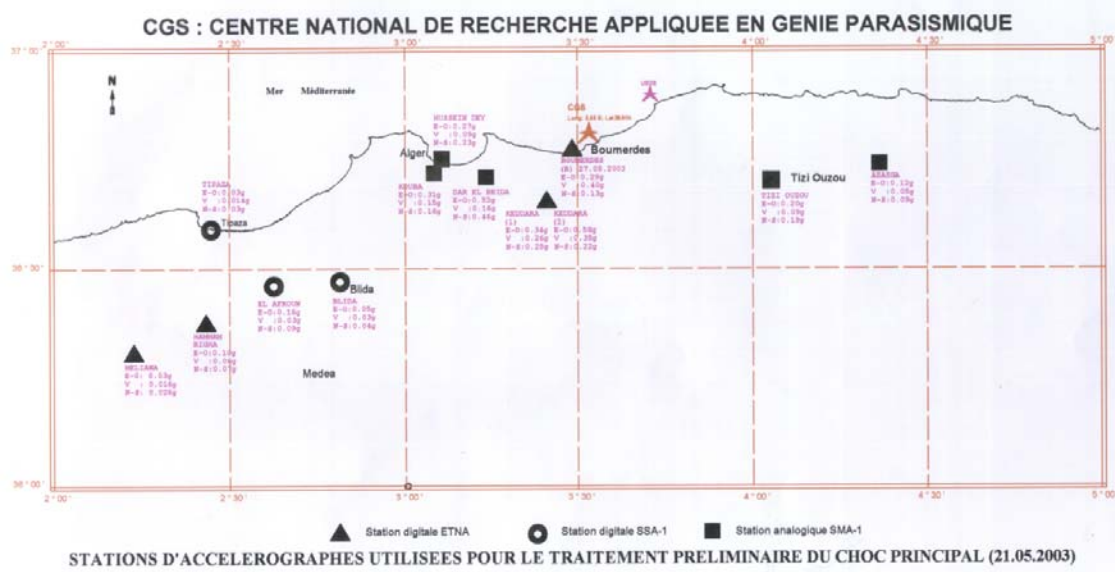
**Figure 16** Instrument location map and recorded ground motions.

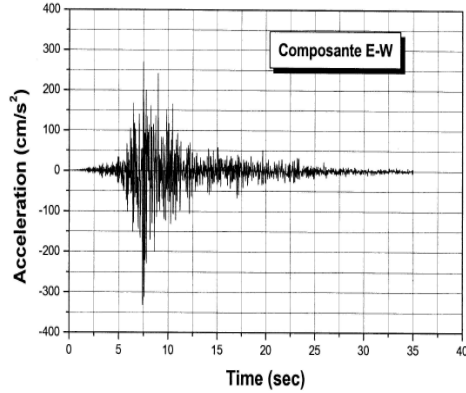
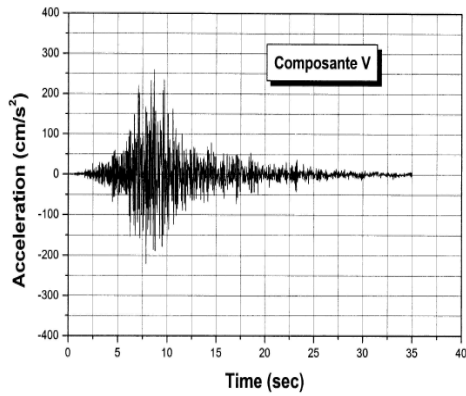
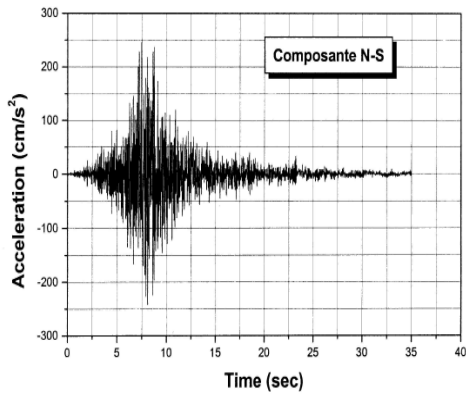
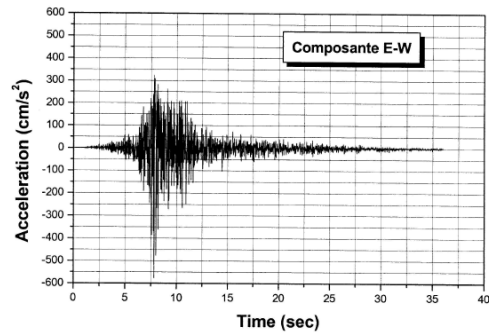
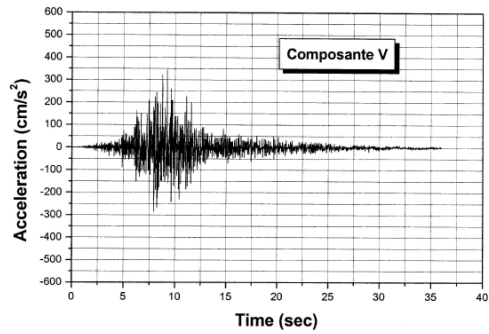
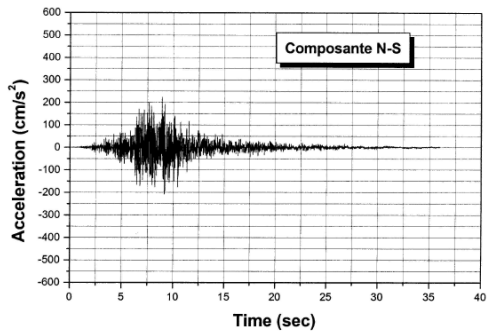
Figure 18 Recorded acceleration time histories from Keddara 1 and Keddara 2 stations.

- c) Soil sites experienced higher accelerations than rock site as exhibited by the difference in motions between Keddara Dam 1 (rock) and Keddara Dam 2 (soil) sites, and also by the high accelerations recorded in Dar El Beida (soil). The strongest ground motions were recorded at the Keddara Dam 2 (soil) site, located about 20 km southwest of the epicenter. The acceleration time histories from Keddara Dam 1 and 2 are shown in Figure 18.

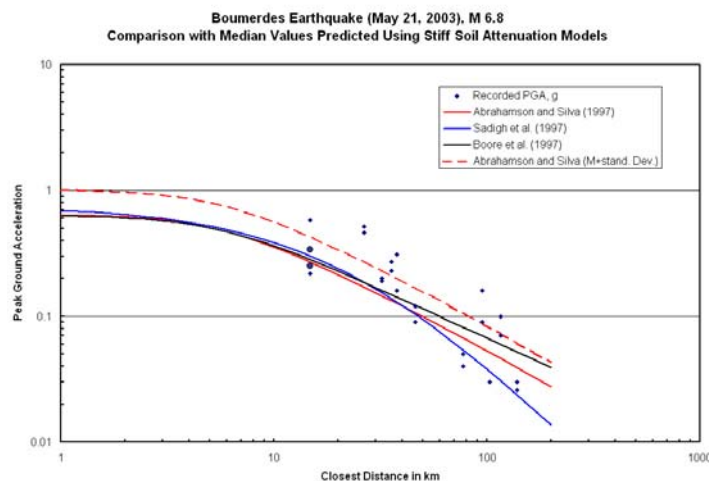
**Figure 19** Recorded PGAs compared to attenuation relationships for soil sites. The two circles represent the rock site at Keddara.

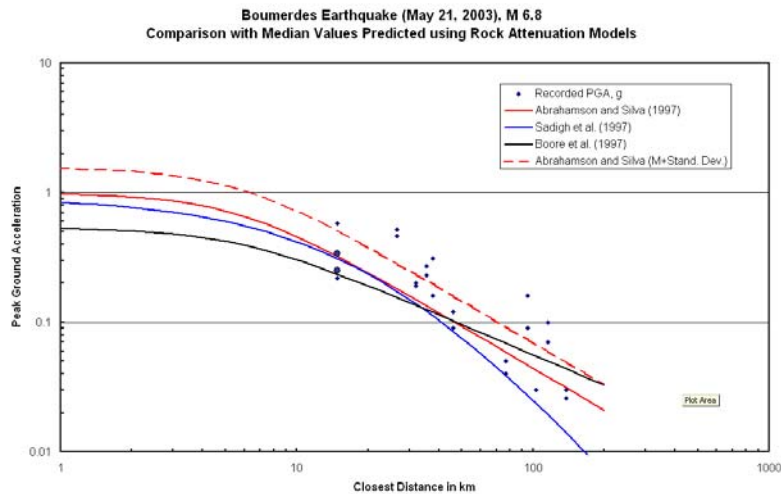
**Figure 20** Recorded PGAs compared to attenuation relationships for rock sites. The two circles represent the rock site at Keddara.

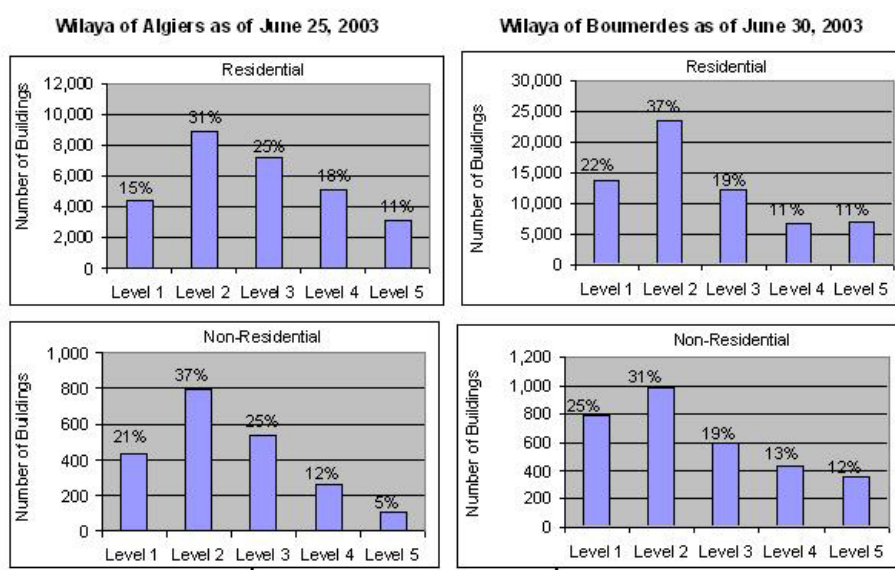
**Figure 38** Damage statistics from building safety surveys (as of June 23, 2003).

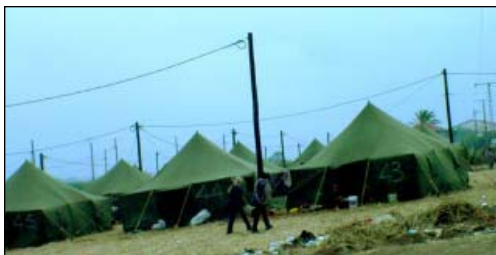
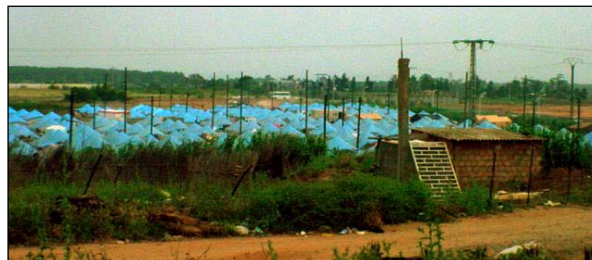
*Figures 56a and b* Tent cities erected by the government to shelter earthquake victims.

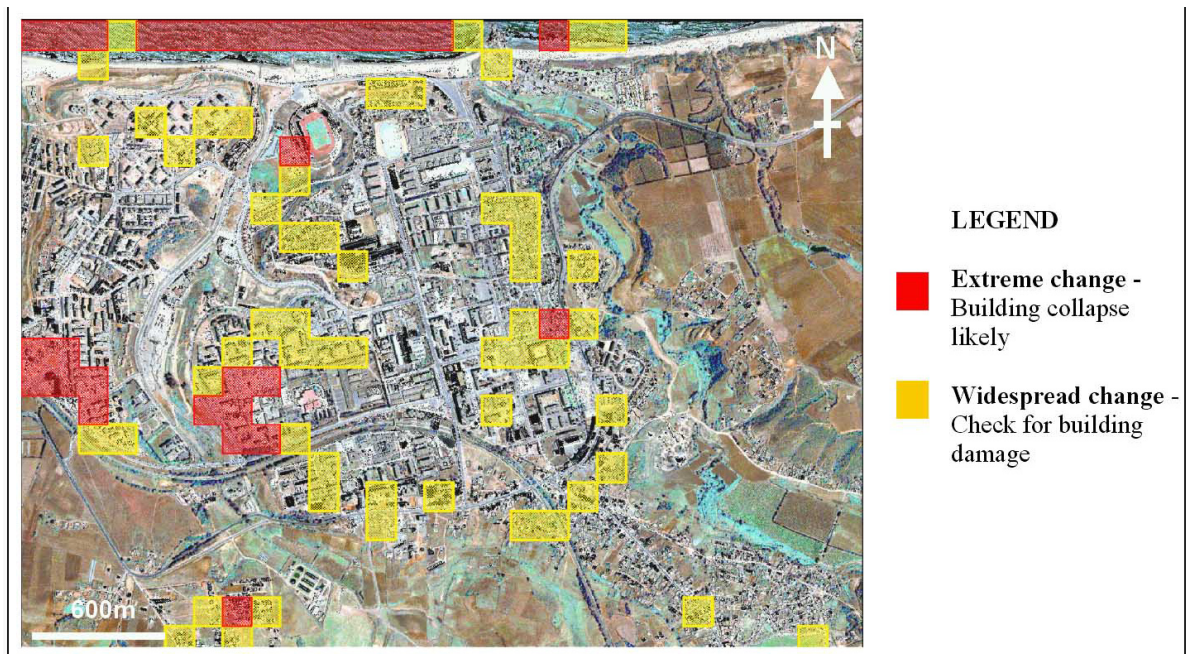
Figure I-3 - Quick-look damage assessment for Boumerdes, obtained using change detection algorithms. Red and orange areas show changes which are primarily due to building damage or the establishment of tent camps. To aid visualization, results are overlaid with the panchromatic

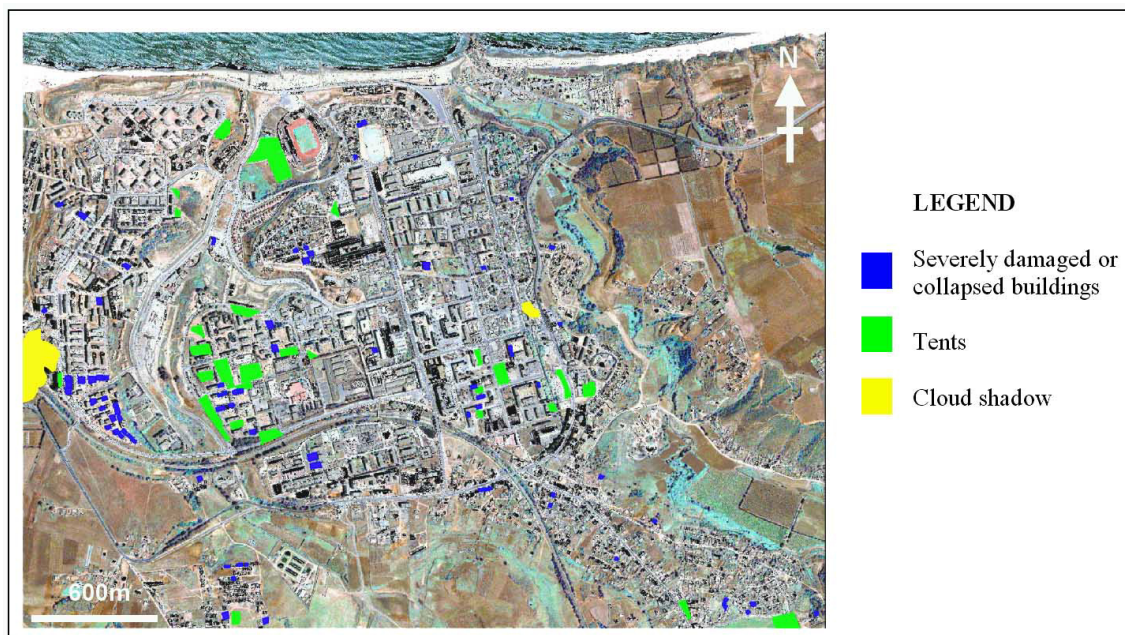
Figure I-4 - Distribution of severely damaged/collapsed buildings and tent camps, identified using visual inspection. To aid visualization, results are overlaid with the panchromatic coverage from 5/23/03. Images courtesy of DigitalGlobe, [www.digitalglobe.com](http://www.digitalglobe.com)

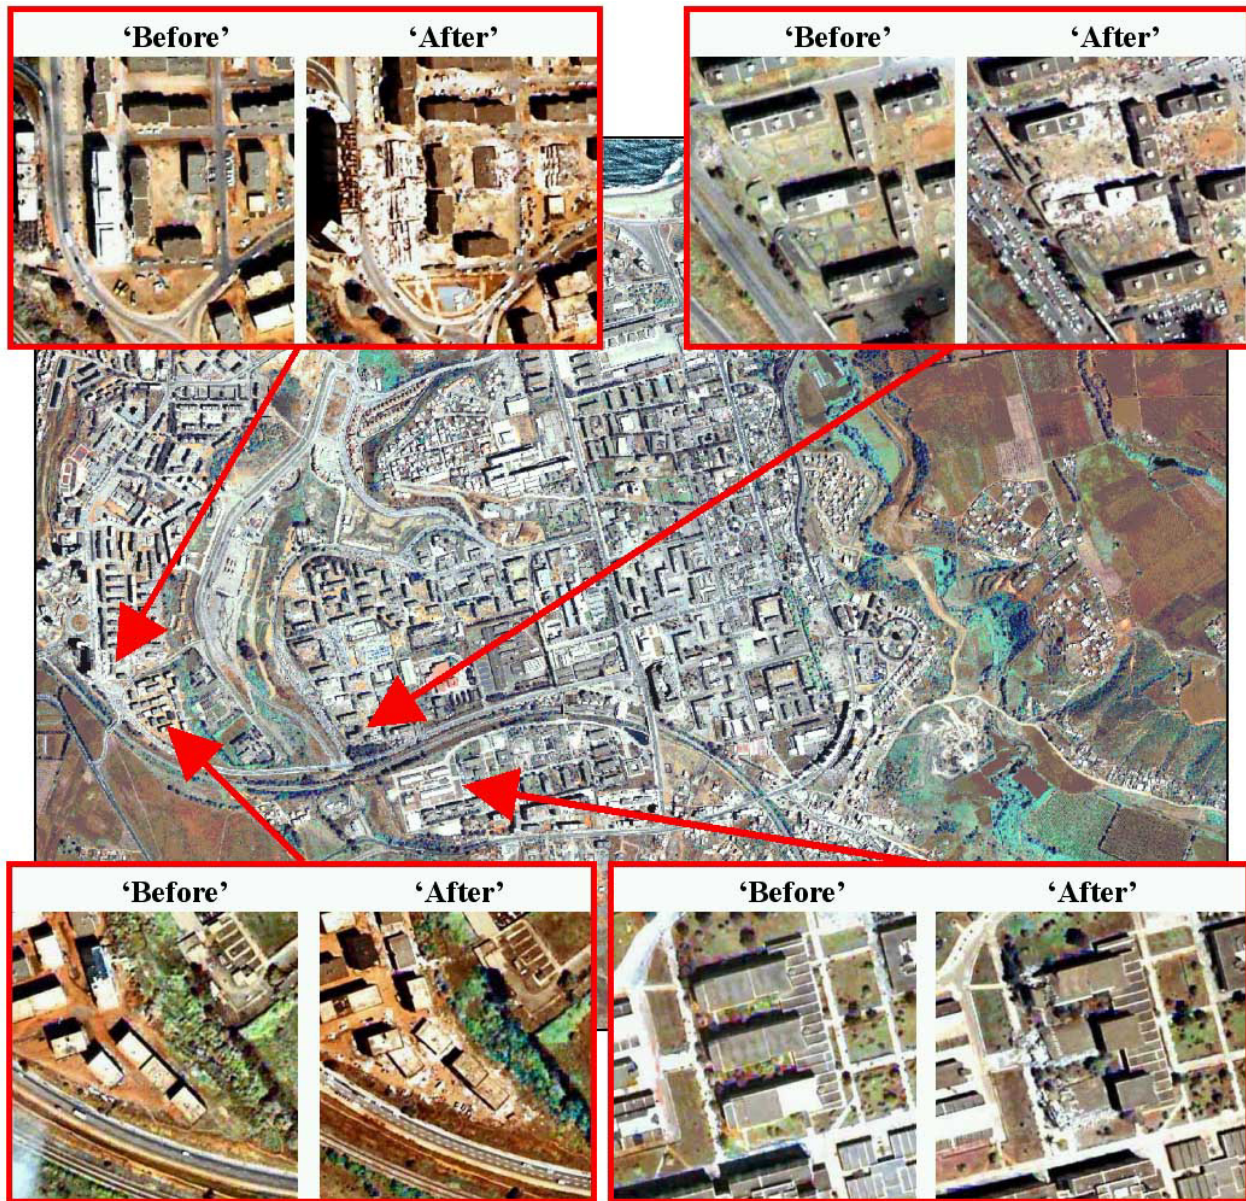
Figure I-5 - Selected examples of building damage in the city of Boumerdes, identified by visual inspection of pan-sharpened QuickBird imagery, acquired before and after the 5/21/03 earthquake. Images courtesy of DigitalGlobe, [www.digitalglobe.com](http://www.digitalglobe.com)

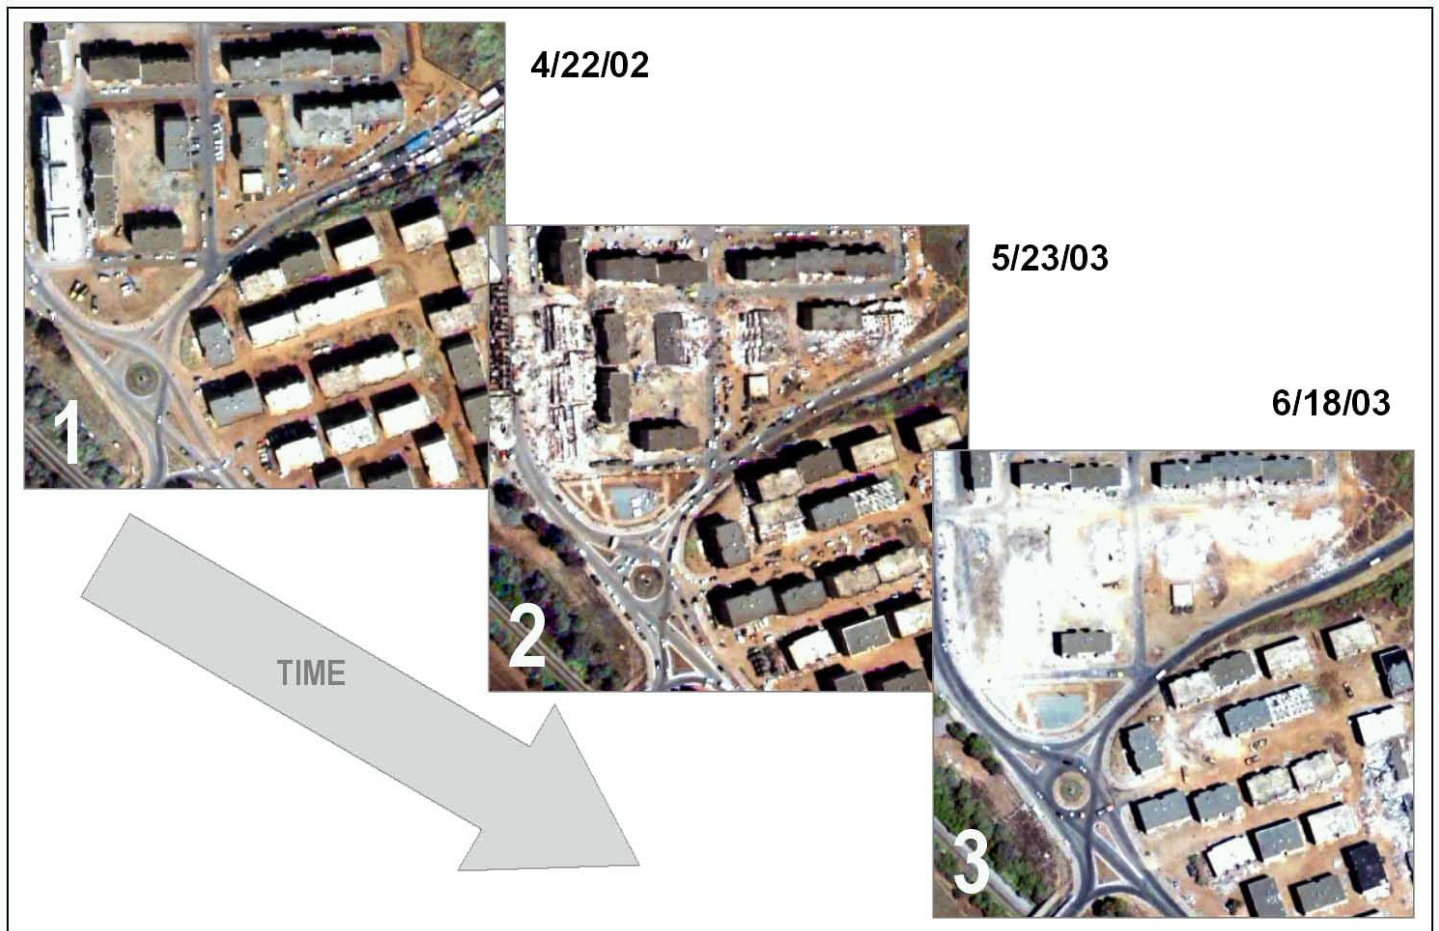
Figure I-6 - Time sequence of QuickBird images, showing apartments in western Boumerdes (1) prior to and (2) soon after the 5/21/03 earthquake. Scene 3 was acquired on 6/18/03, and shows progress made with clean-up operations.
